SAFETY ALERT BULLETIN

ACCIDENT REDUCTION PROGRAM

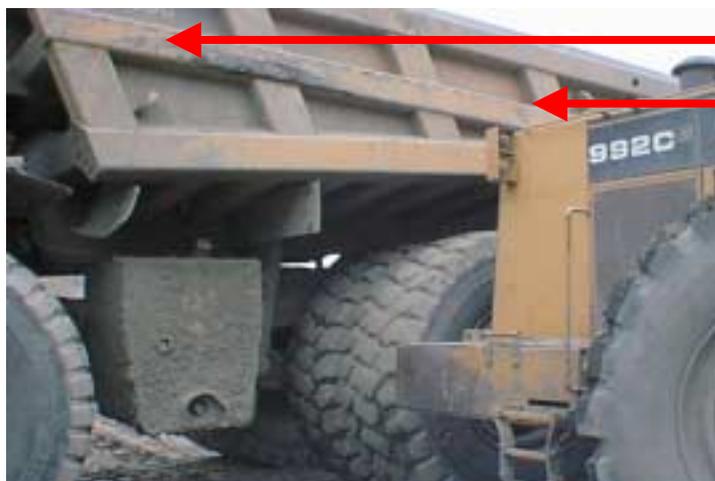
Area of rock guard, ten inches wide and ten feet long-weighing approximately 100 pounds.

On Saturday, February 14, 2004, a contract welder received serious injuries in an accident that occurred while he was replacing a metal rock guard on a 785C Caterpillar rock hauler. The victim, who was standing on a ladder approximately 10 feet above the ground, was using an oxyacetylene torch to cut the weld that secured the guard to the truck. He had cut most of the old weld from the metal guard but had intentionally left a couple places “spot welded” to prevent the guard from prematurely falling. The victim planned to cut the majority of the weld while leaving the “spot welded” locations and then finish removing the guard by breaking the spot welds with a 992C loader bucket. While not visible and unknown to the victim, the “spot welds” were broken at the weld-frame junction. The rock guard broke loose and struck the victim in the face causing lacerations. The victim jumped from the ladder onto the ground and sustained a broken left leg.

- When removing an object from elevated locations, the object should be secured to prevent it from falling accidentally.
- Equipment components scheduled for repairs or replacement should be thoroughly examined, prior to working a such equipment, for stability and potential of falling.
